## Case Study

*"1 Year Roof Rejuvenation & Oil Replenishment"*

# Fine Oil Replenishment – Asphalt Shingles

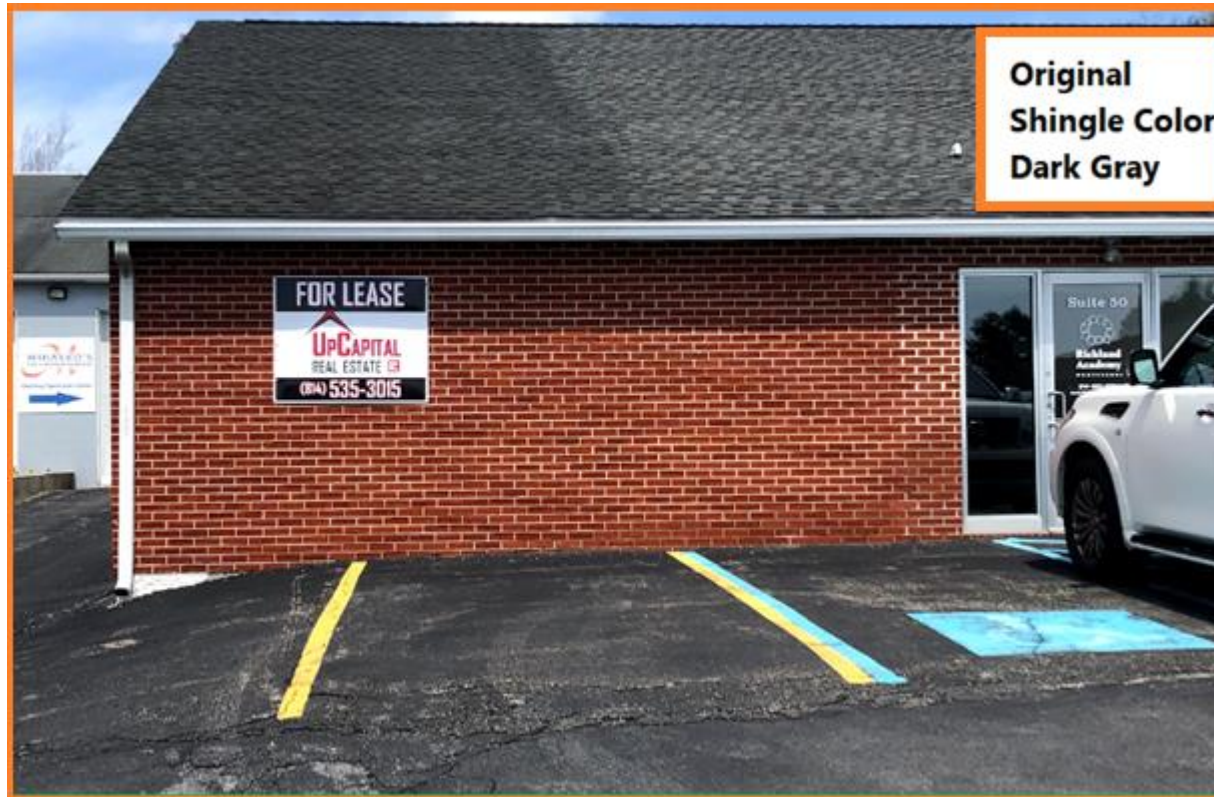
Unsprayed/Untreated

# Oil Replenishment – 6 months after first treatment

Photo Taken 6 months  
after treatment 4/1/2020

- Asphalt Shingles – 17 years old. Dry, brittle and aged. Nearing end of lifespan.
- Western, Pennsylvania.
- Four Seasons (Summer, Fall, Winter, Spring.)
- Commercial Property.

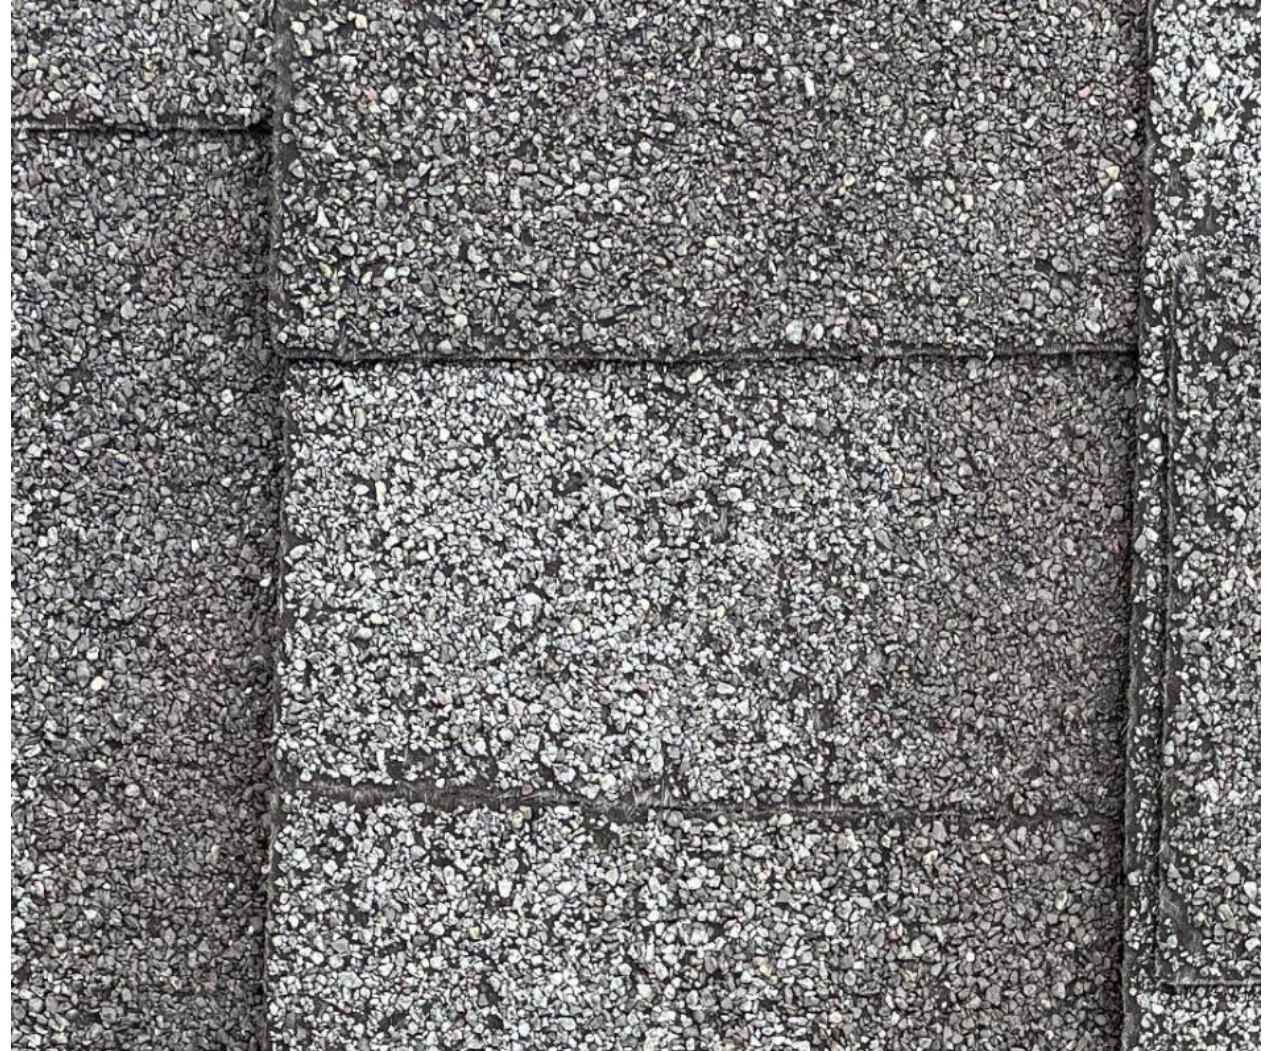
Rejuvenated Closeup

- Asphalt completely replenished and rejuvenated.
- Pliability and Flexibility returned.
- Aging process stopped

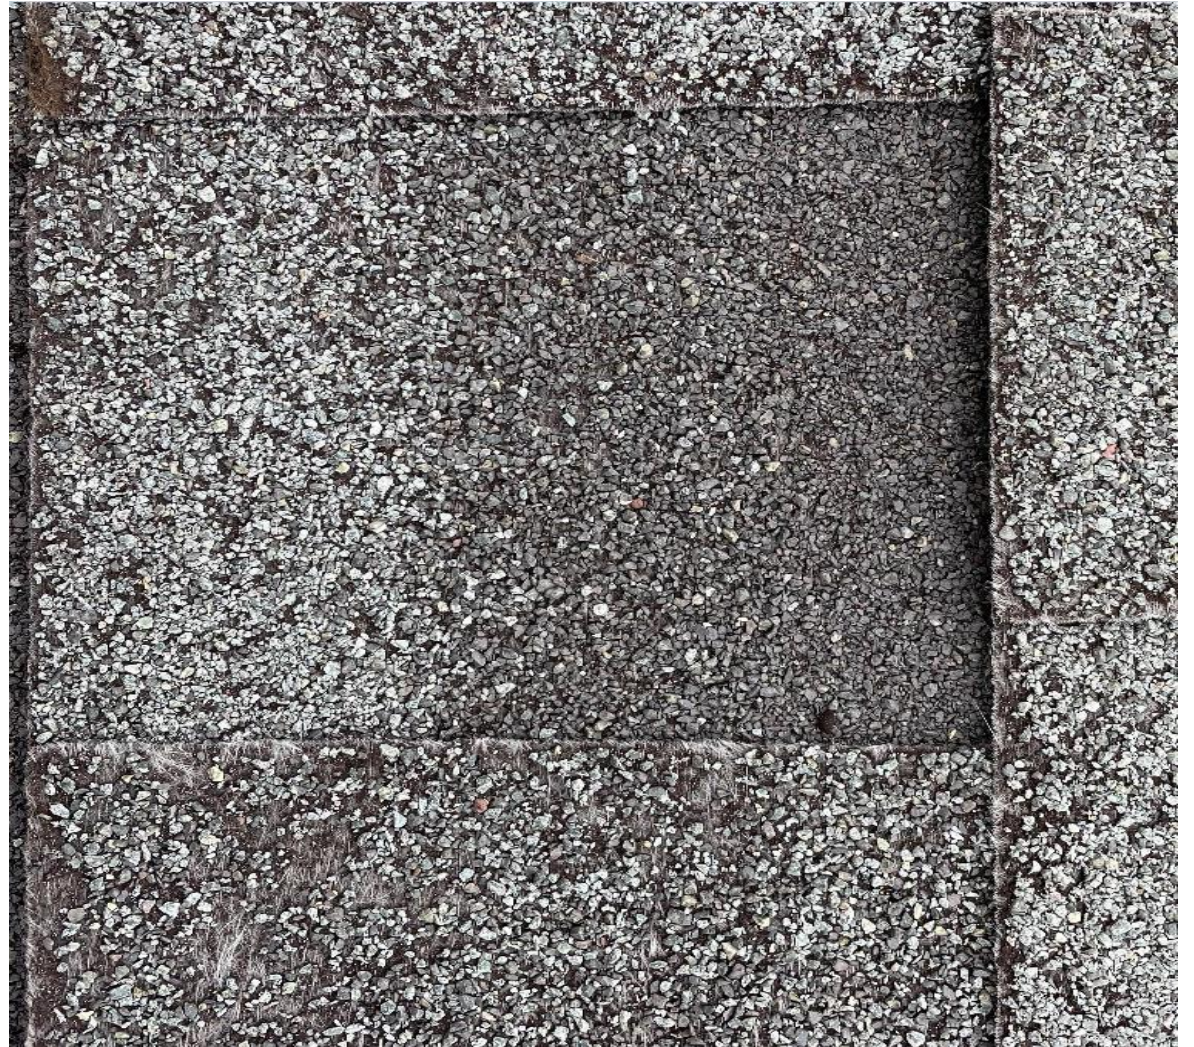
Untreated Closeup

- Dry, Brittle
- Cracking.
- Aging daily.

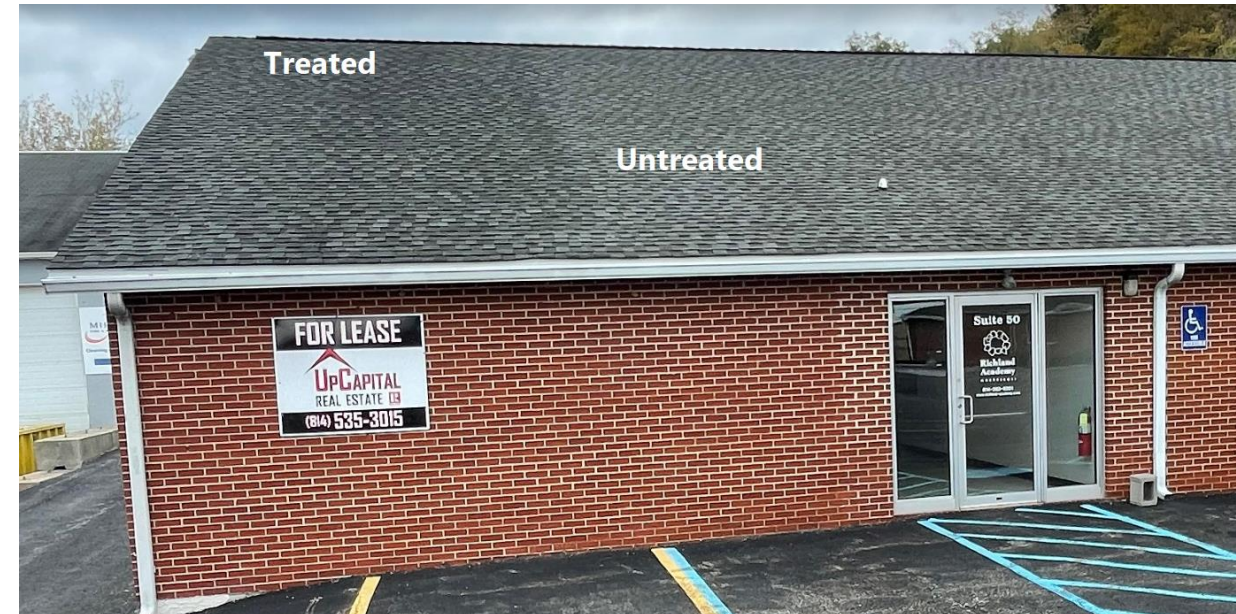
Photos taken head-on 10/3/2021 →

Replenished and near original  
installation color
