## Case Study

*"1 Year Roof Rejuvenation & Oil Replenishment"*

# Fine Oil Replenishment – Asphalt Shingles

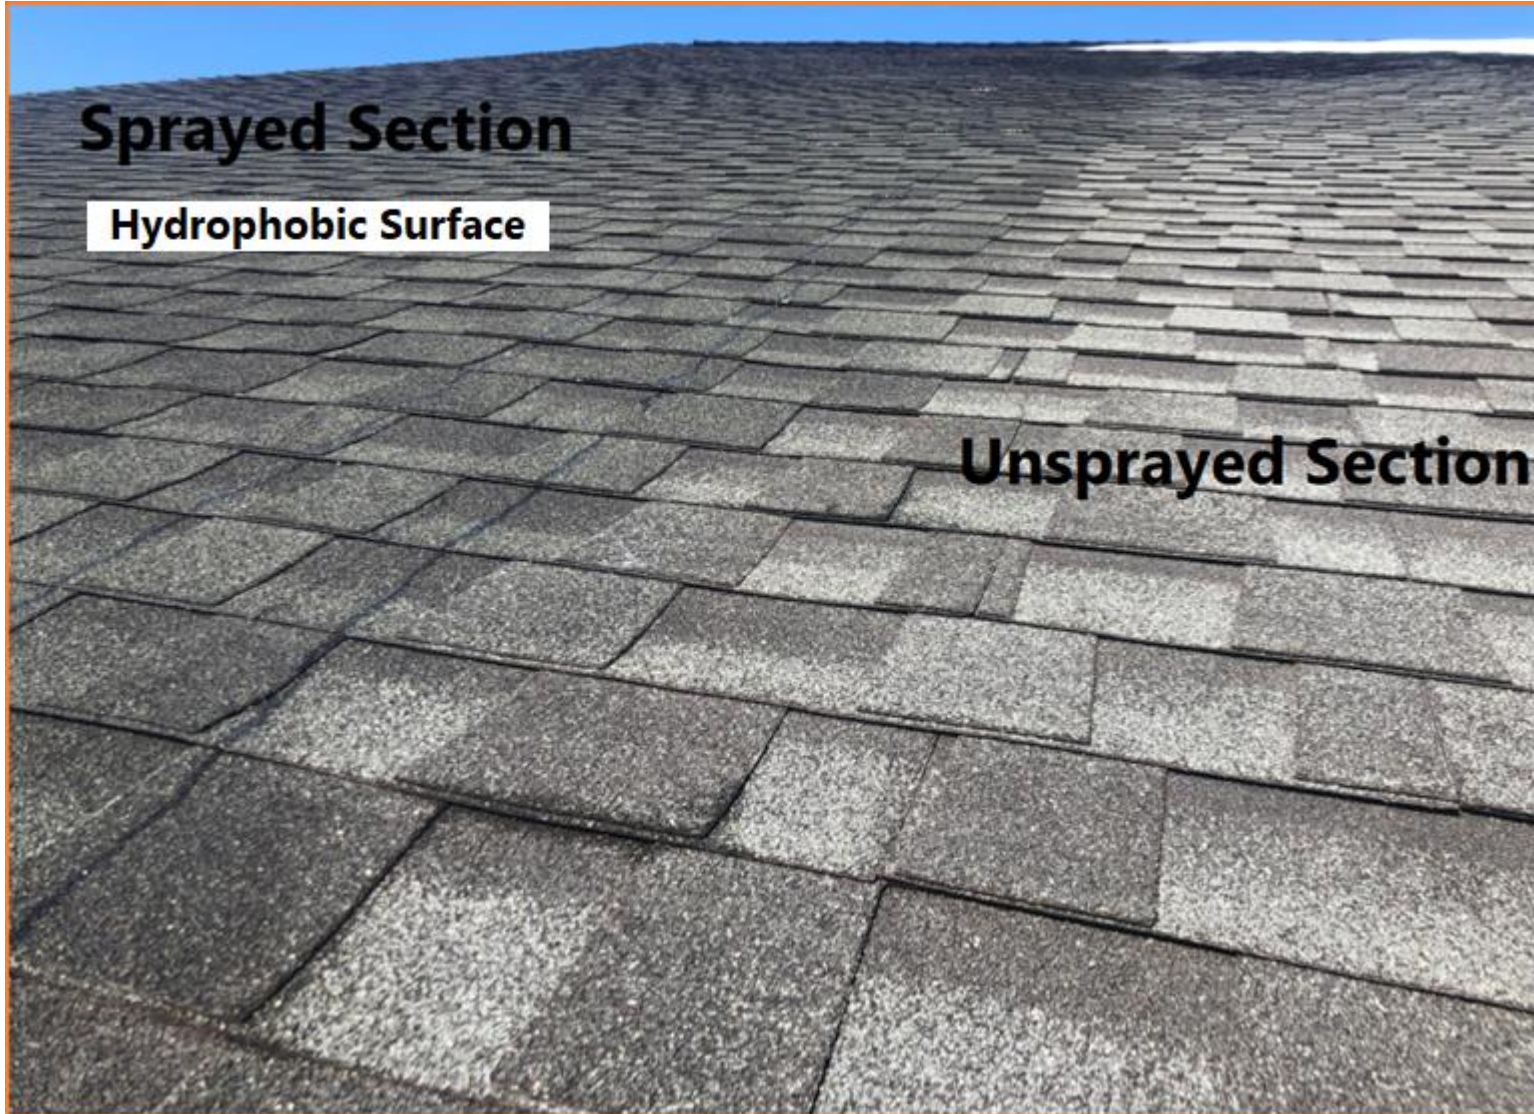
# Snowmelt Winter 2020 – 5 Months after first Treatment

## Roof Rejuv Treatment October 2020

- Asphalt Shingles – 17 years old. Dry, brittle and aged. Nearing end of lifespan.
- Western, Pennsylvania.
- Four Seasons (Summer, Fall, Winter, Spring.)
- Commercial Property.

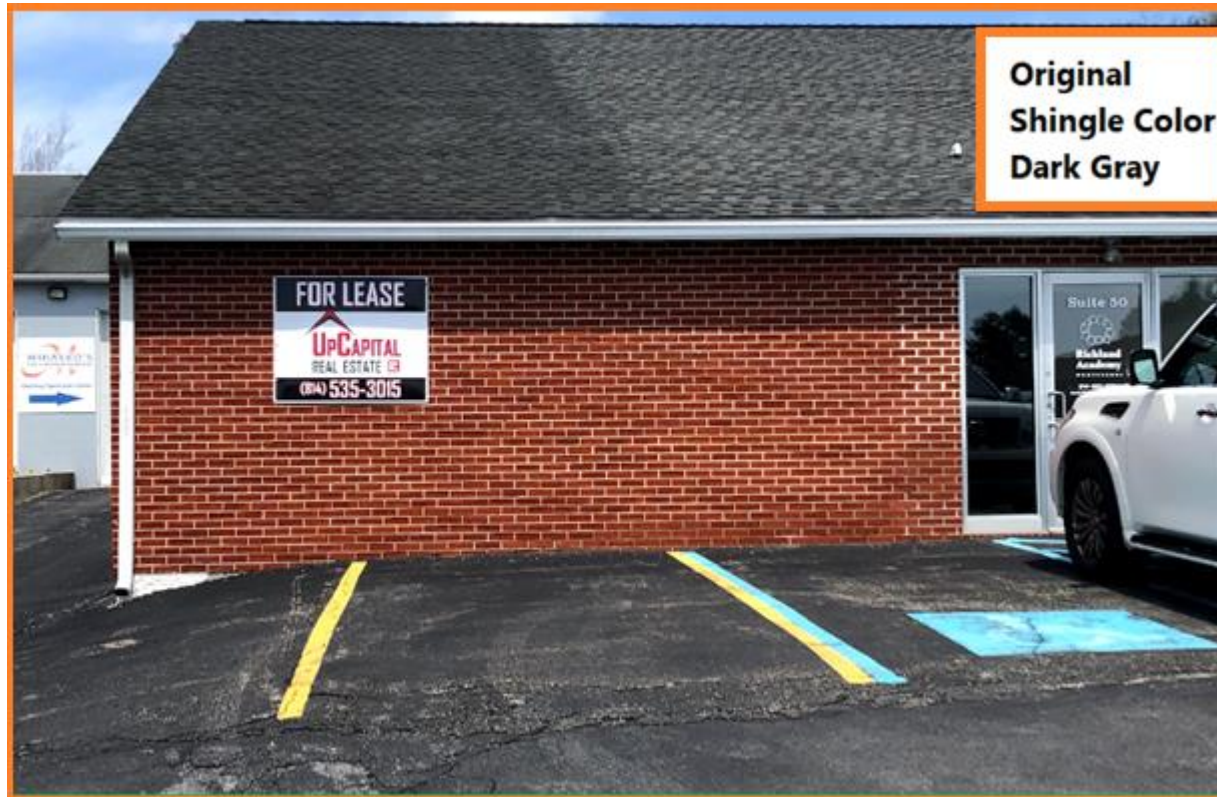
Unsprayed/Untreated

# Oil Replenishment – 6 months after first treatment

Photo Taken 6 months  
after treatment 4/1/2020

Roof Rejuv Treatment October 2020

- Asphalt Shingles – 17 years old. Dry, brittle and aged. Nearing end of lifespan.
- Western, Pennsylvania.
- Four Seasons (Summer, Fall, Winter, Spring.)
- Commercial Property.

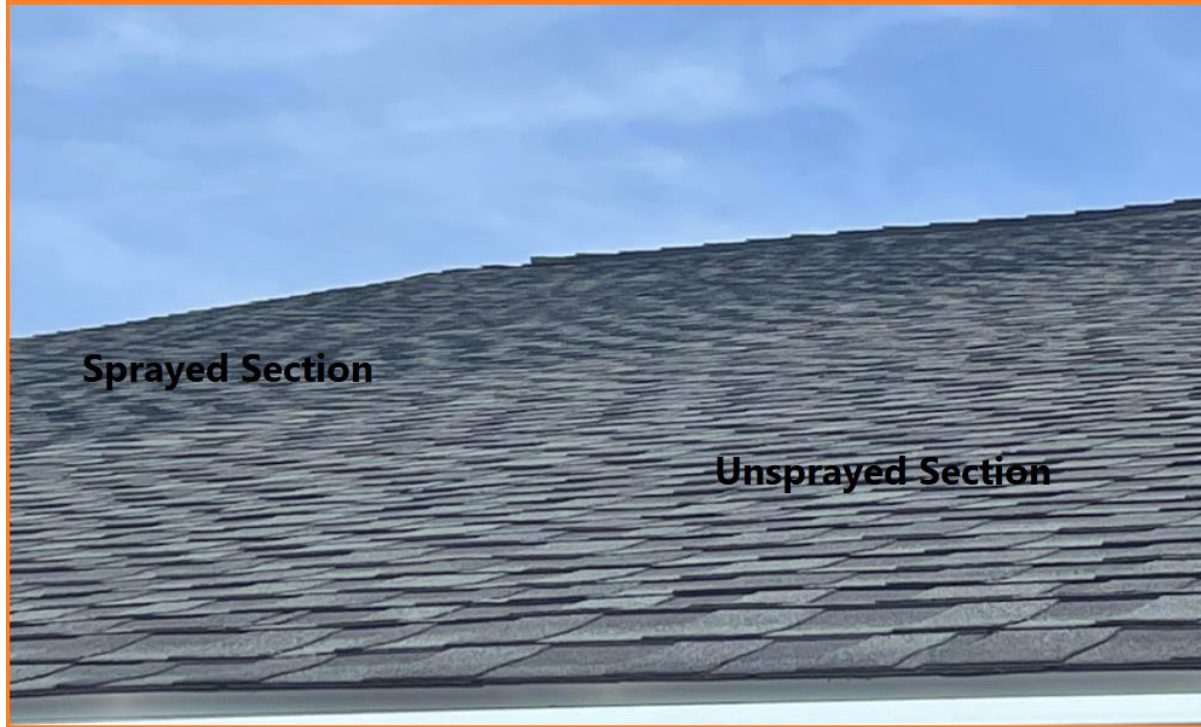
Photos taken at side angle  
10/1/2021

Replenished and near original  
installation color

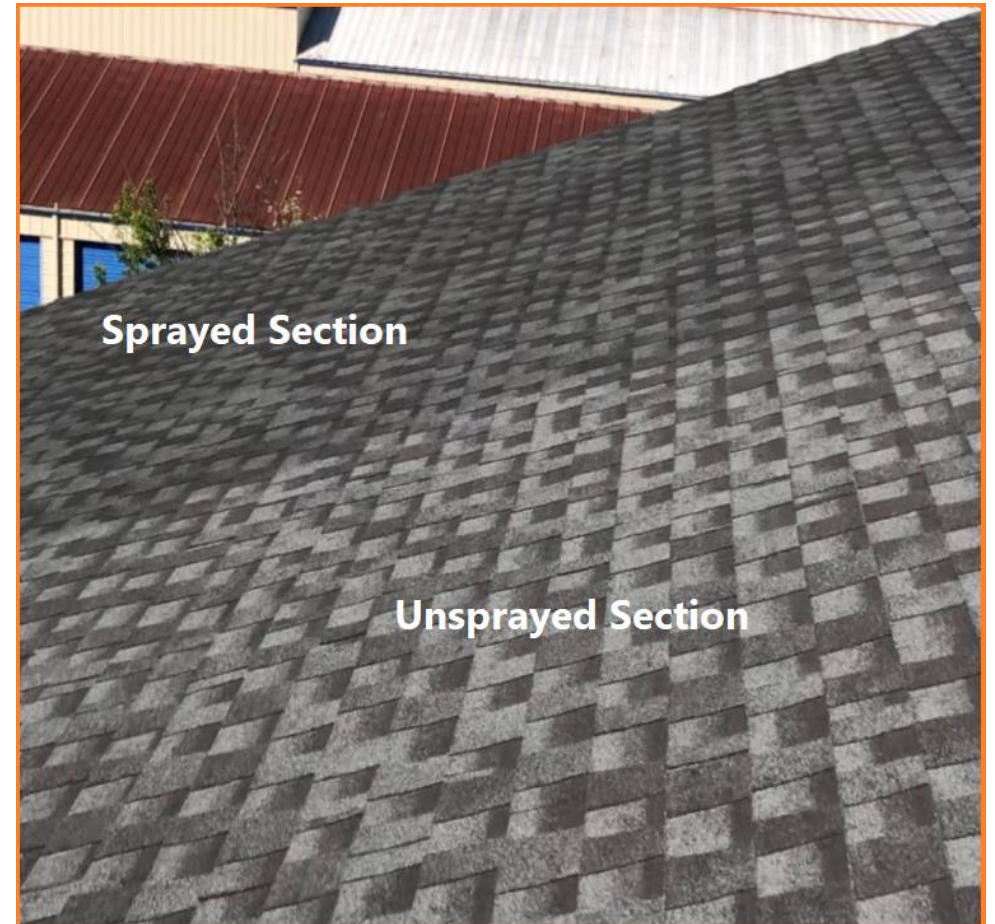
Photos Taken 10/1/2021

← 1 full year after first shingle treatment →

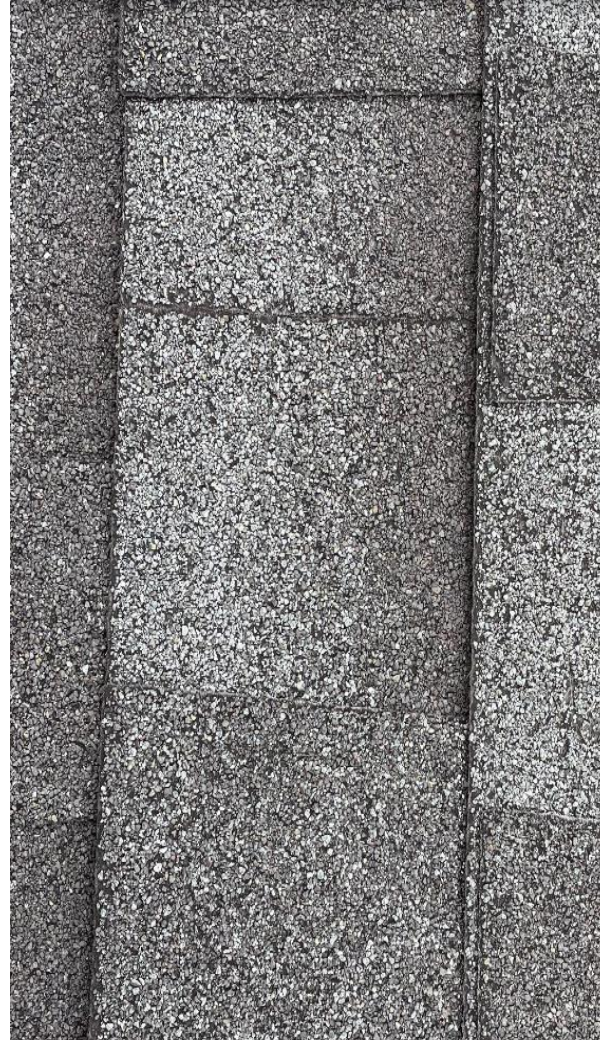
Rejuvenated

Photos Taken 10/1/2021

1 full year after first shingle treatment

- Asphalt completely replenished and rejuvenated.
- Pliability and Flexibility returned.
- Aging process stopped.

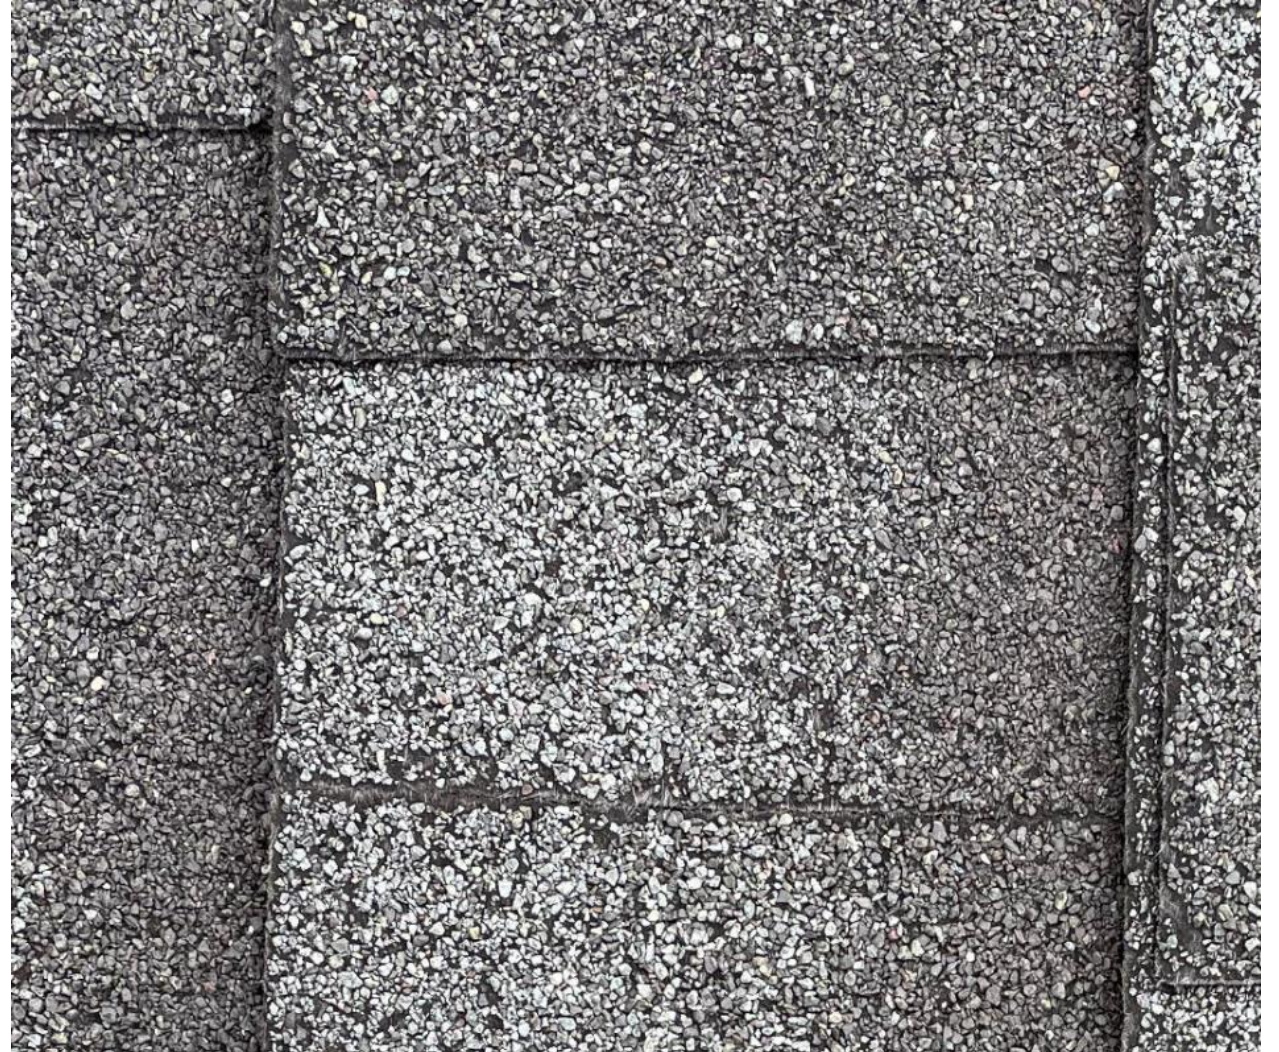
Rejuvenated Closeup

Photos Taken 10/1/2021

1 full year after first shingle treatment

- Asphalt completely replenished and rejuvenated.
- Pliability and Flexibility returned.
- Aging process halted.

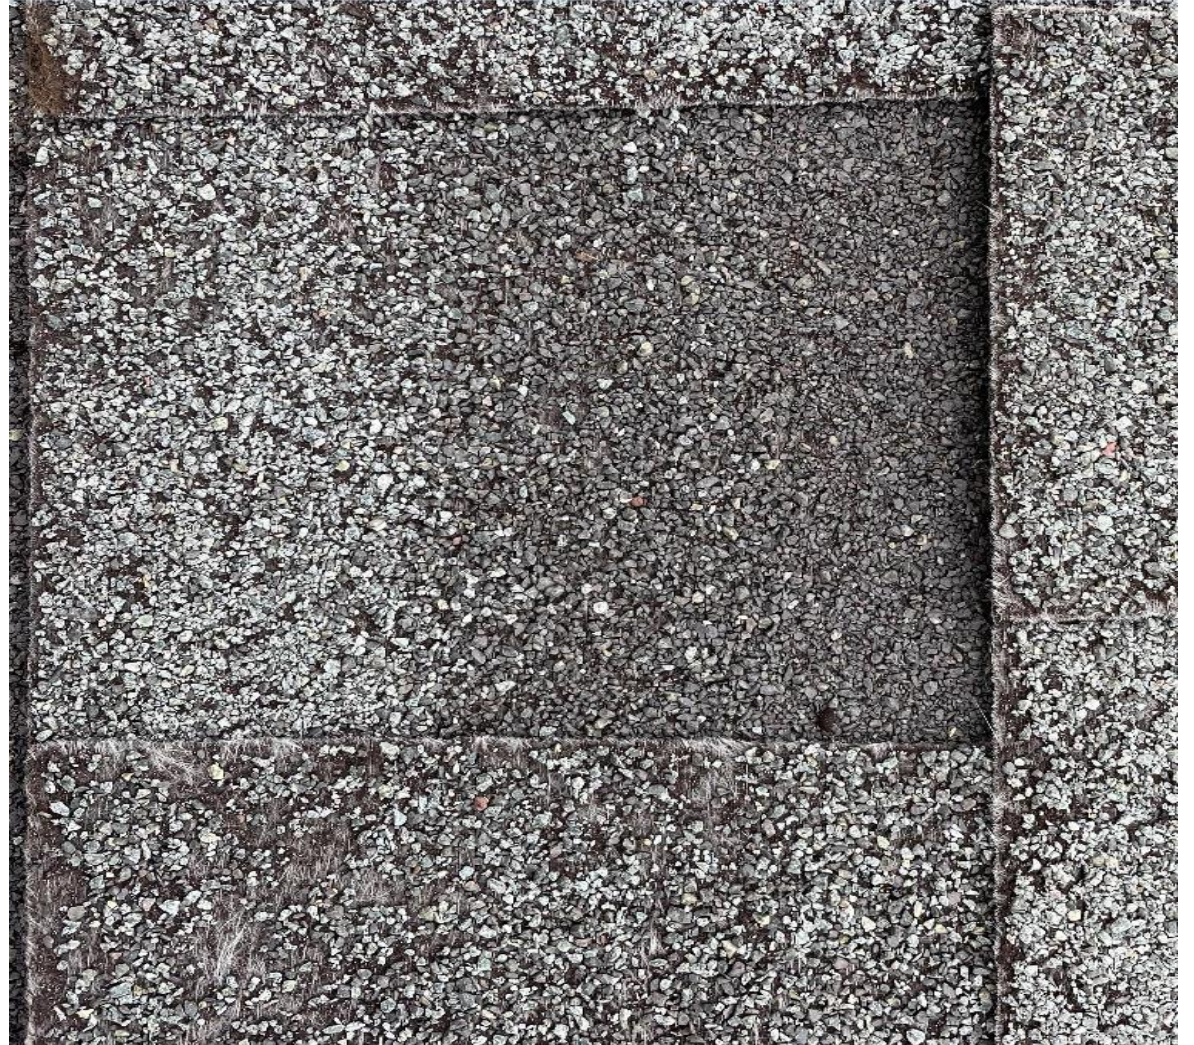
Untreated Closeup

Photos Taken 10/1/2021

- Dry, Brittle
- Cracking.
- Aging daily.

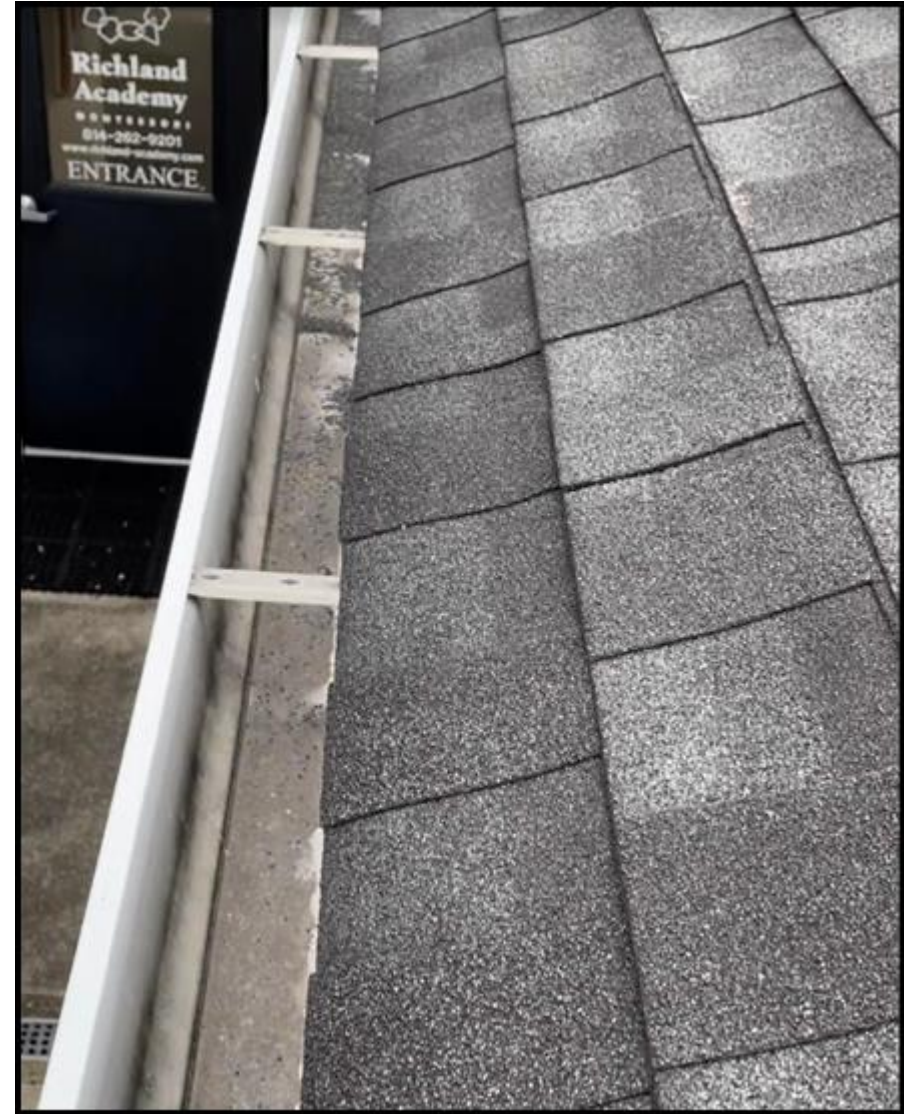
Photos Taken 10/1/2021

1 full year after first shingle treatment

- Gutter full of Aggregate on unsprayed section. Granular in tact on sprayed section.
- Gutter Clean on sprayed section

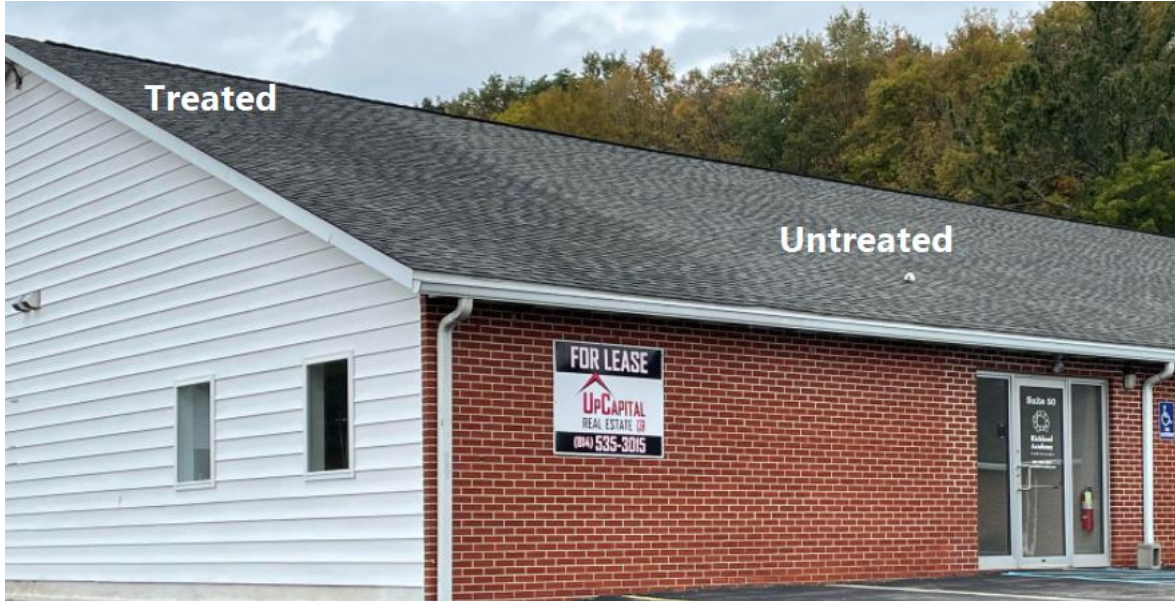
Photos Taken 10/3/2021

← 1 full year after first shingle treatment

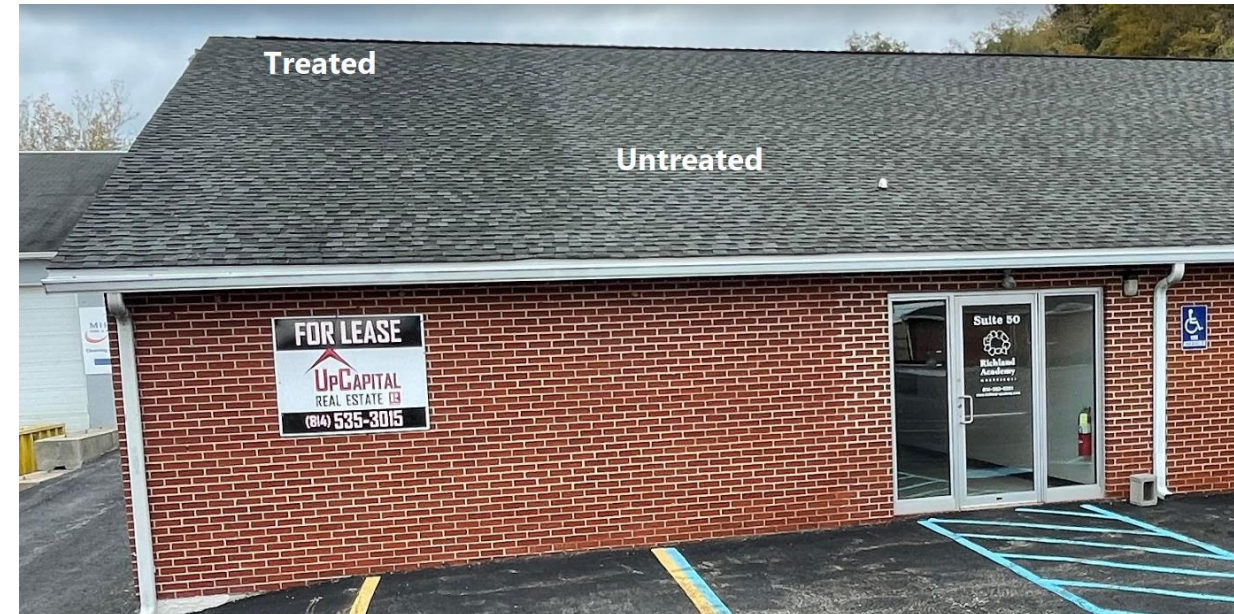
Photos taken head-on 10/3/2021 →

Replenished and near original  
installation color
